The Road Inventory of Nisqually National Wildlife Refuge Olympia, WA

Prepared By: Federal Highway Administration Central Federal Lands Highway Division April 2013

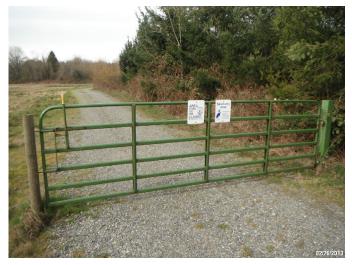
Photo: NISQ_C4_0351 Route: 403-001-0.0 Metal Open Rail Gate

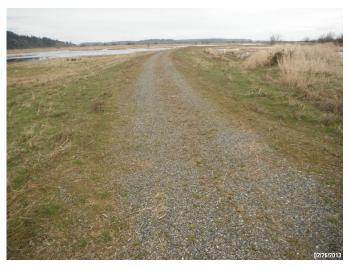
Photo: NISQ_C4_0352 Route: 403-002-0.16 Begin Section

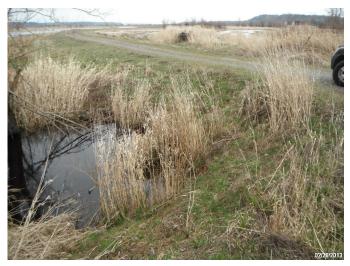
Photo: NISQ_C4_0361 Route: 403-003-0.29 Plastic WCS Flashboard Riser 40ft long 24in dia. 3ft deep 8-008

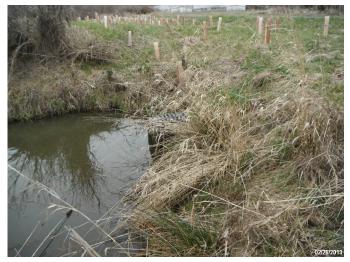
Photo: NISQ_C4_0365 Route: 403-003-0.74 Plastic WCS Flashboard Riser 60ft long 24in dia. 3ft deep

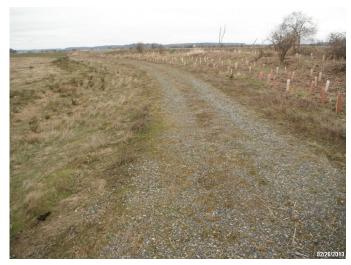
Photo: NISQ_C4_0366 Route: 403-004-0.73 Begin Section

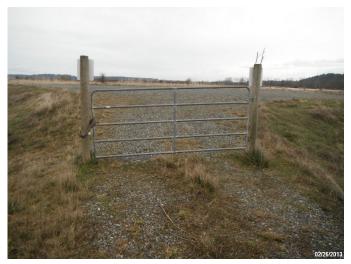
Photo: NISQ_C4_0367 Route: 403-004-0.8 Metal Open Rail Gate

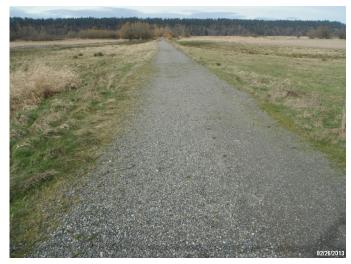
Photo: NISQ_C4_0353 Route: 404-001-0.0 Begin Section

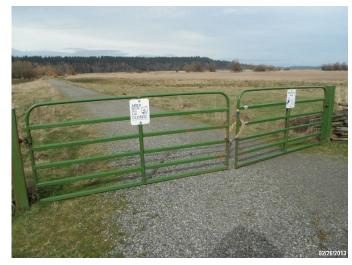
Photo: NISQ_C4_0354 Route: 404-001-0.0 Metal Open Rail Gate

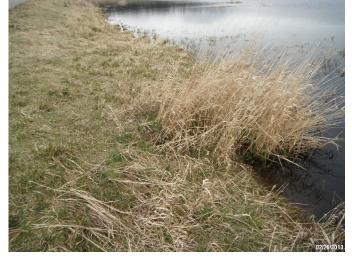
Photo: NISQ_C4_0358 Route: 404-001-0.3 Plastic WCS Flashboard Riser 40ft long 24in dia. 3ft deep 8-010

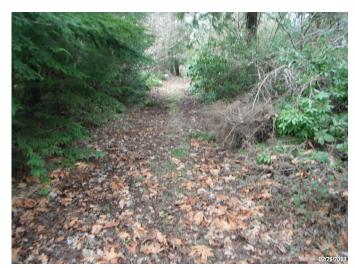
Photo: NISQ_C4_0369 Route: 405-001-0.0 Begin Section

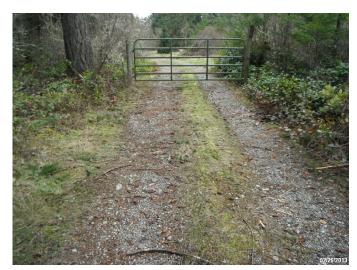
Photo: NISQ_C4_0371 Route: 406-001-0.0 Begin Section

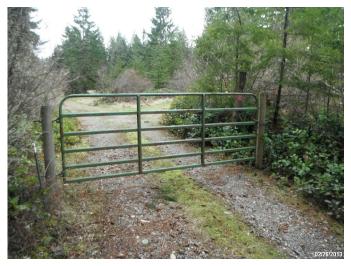
Photo: NISQ_C4_0372 Route: 406-001-0.0 Metal Open Rail Gate

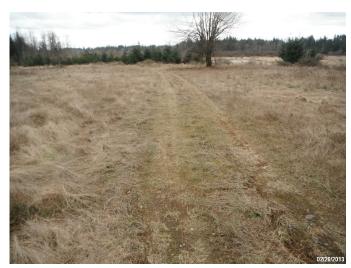
Photo: NISQ_C4_0373 Route: 407-001-0.0 Begin Section

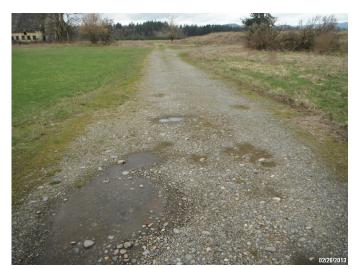
Photo: NISQ_C4_0375 Route: 408-001-0.0 Begin Section

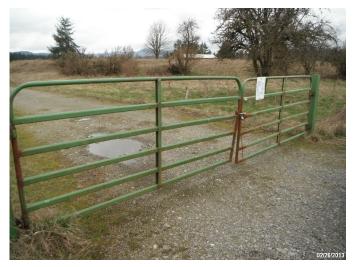
Photo: NISQ_C4_0376 Route: 408-001-0.0 Metal Open Rail Gate

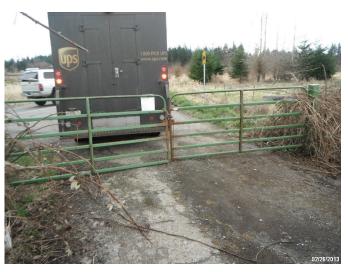
Photo: NISQ_C4_0377 Route: 408-001-0.82 Metal Open Rail Gate

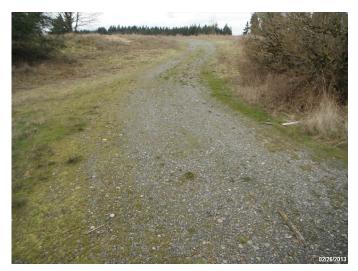
Photo: NISQ_C4_0378 Route: 408-002-0.03 Begin Section

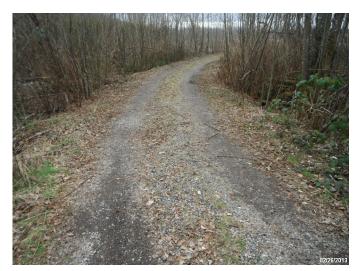
Photo: NISQ_C4_0379 Route: 409-001-0.0 Begin Section

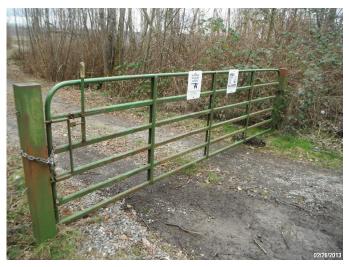
Photo: NISQ_C4_0380 Route: 409-001-0.0 Metal Open Rail Gate

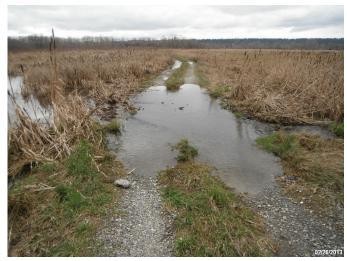
Photo: NISQ_C4_0383 Route: 409-001-0.15 Obstacle Road flooded, could not continue

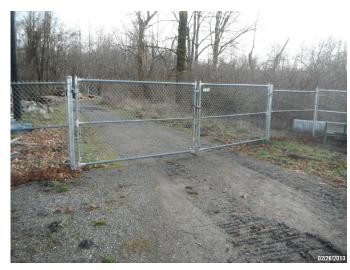
Photo: NISQ_C4_0326 Route: 800 Metal Chain Link Gate

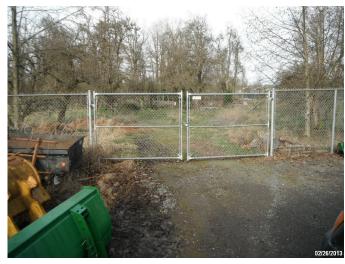
Photo: NISQ_C4_0327 Route: 800 Metal Chain Link Gate

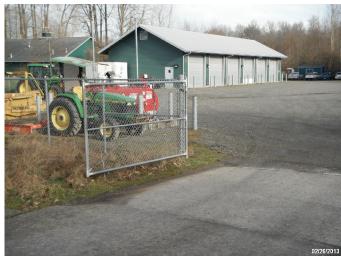
Photo: NISQ_C4_0328 Route: 800 Metal Chain Link Gate

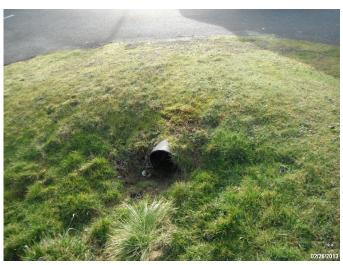
Photo: NISQ_C4_0316 Route: 901 Plastic Culvert 45ft long 12in dia. 1ft deep

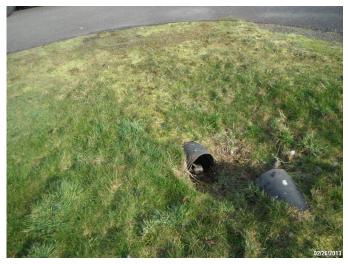
Photo: NISQ_C4_0317 Route: 901 Plastic Culvert 45ft long 12in dia. 1ft deep
